WRDC-TR-89-3075

FULL-SCALE BIRDSTRIKE TESTING OF IN-SERVICE
AGED F-111 ADBIRT WINDSHIELD TRANSPARENCIES

University of Dayton Research Institute
300 College Park Avenue
Dayton OH 45469

Interim Report for Period May 1985 - November 1987

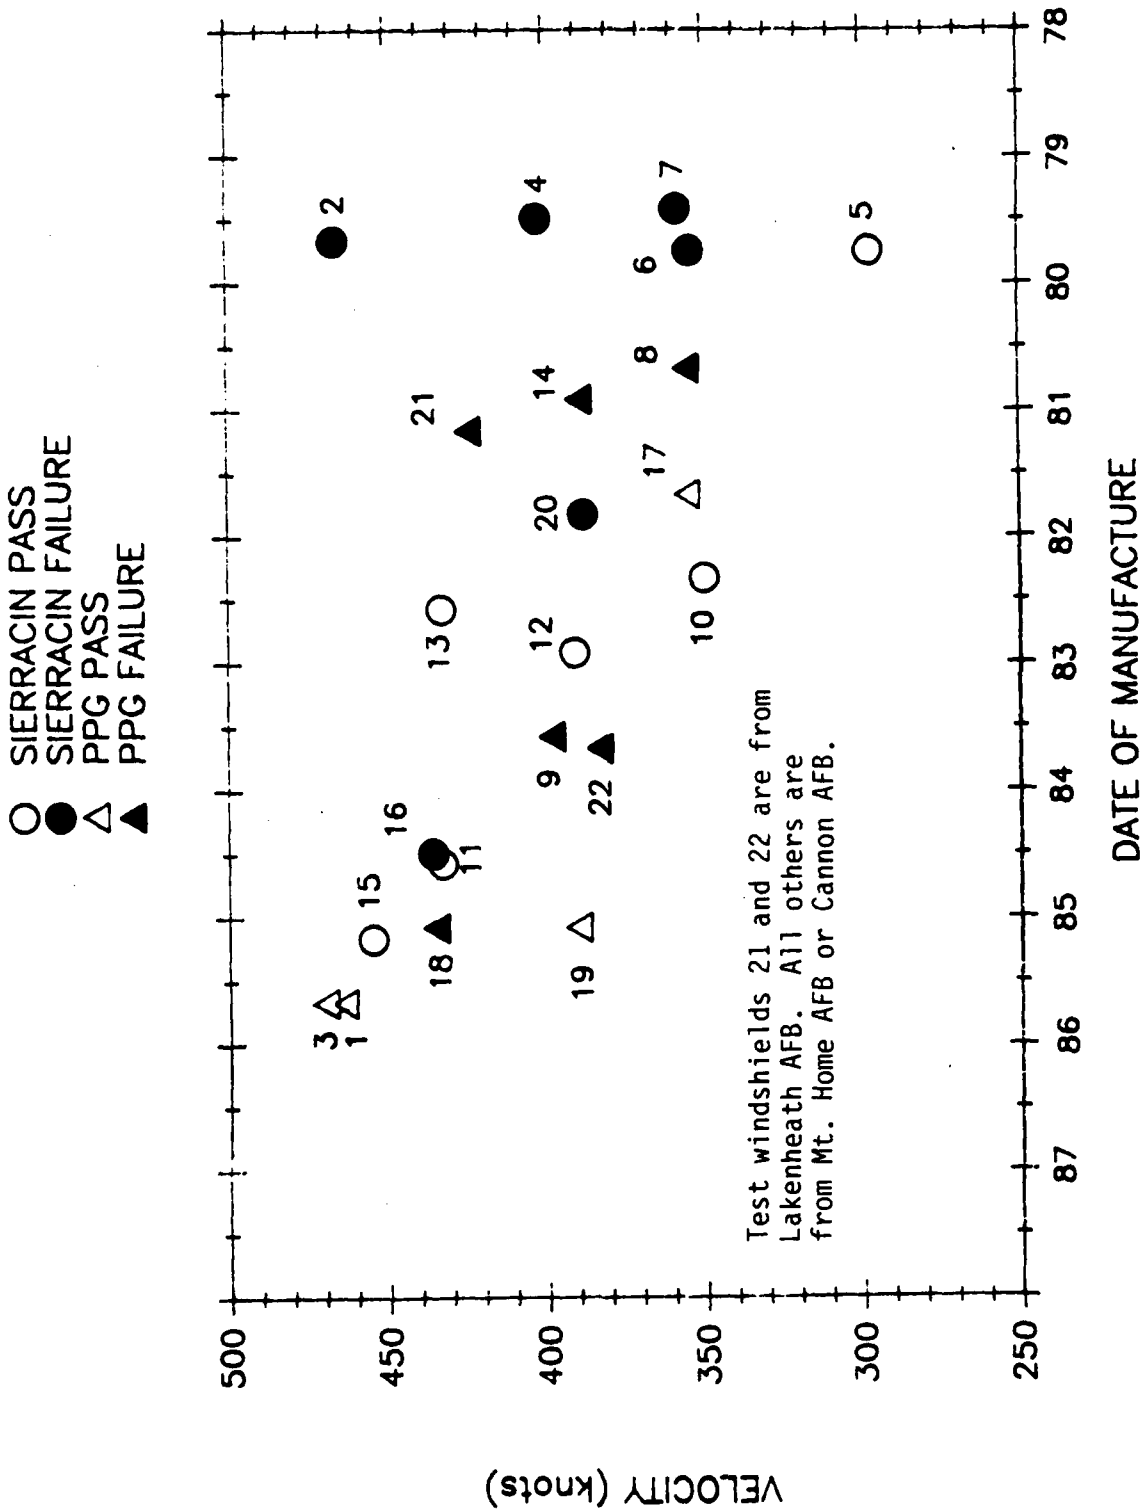
Figure 14. Test Data Summary, Velocity vs. Date of Manufacture.

degradation is related only to the date of manufacture. Figure 14 is a plot of birdstrike resistance capability versus date of manufacture. No trend is evident from this plot, although at least one source in the literature indicates a reduction in bare polycarbonate impact strength with absolute age.⁷ A plot of birdstrike resistance capability versus installed age (date of installation subtracted from date of removal) is presented for each vendor in Figure 15. (Note that a predicted capability curve for 0.725 inch stretched acrylic is included.*) This plot indicates a definite relationship between installed age and degradation. The actual cause of degradation may be a complex combination of extrinsic factors including absolute age, installed age, geographic location, and more specific intrinsic factors such as total UV exposure, thermal history, fatigue, hydrolysis, and molecular attack. Table 4 presents a comparison of baseline and in-service aged windshield birdstrike resistance.

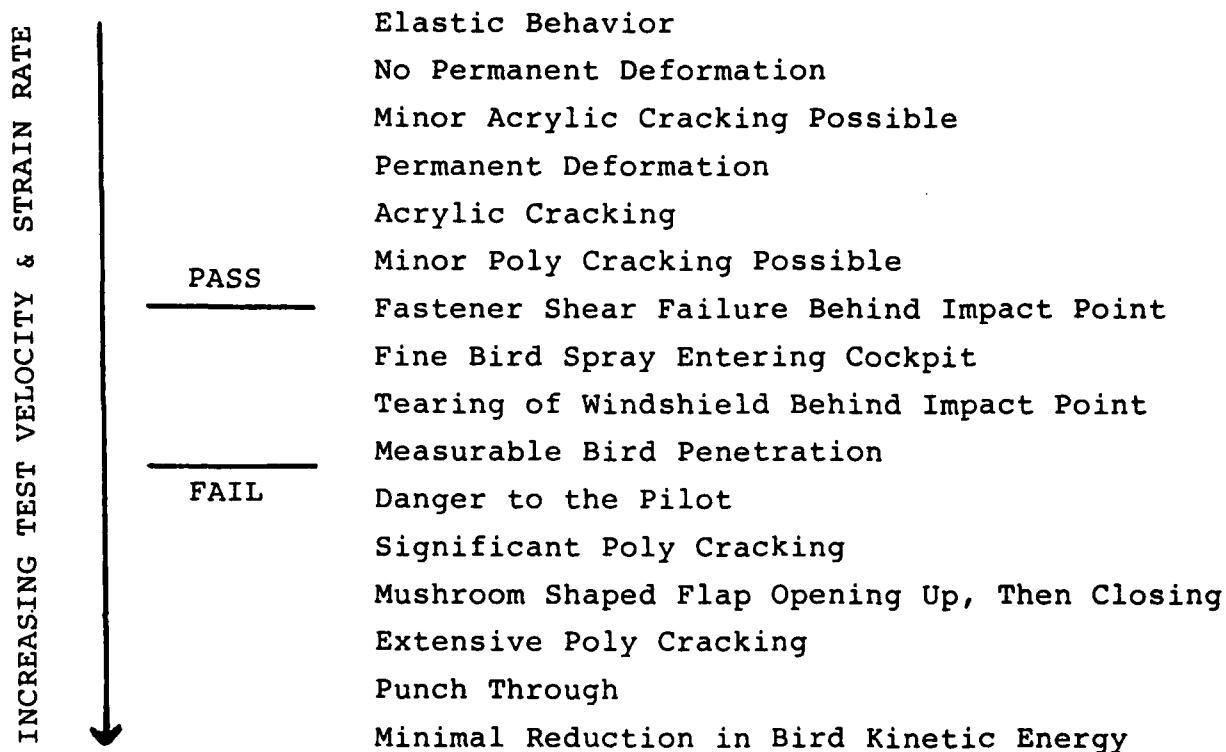
Figure 16. Effect of Increasing Test Velocity on Windshield Damage for Service-Aged Windshields.

There is a change in failure mode between the degraded and baseline windshields. When shot at velocities exceeding their capability, new windshields are ductile and crack resistant, absorb energy, and maintain coherency (no spalling). The degraded windshields, however, have decreased crack tolerance, absorb little energy (minimum plastic deformation), and have a tendency to spall. The effect of increasing velocity and strain rate on transparency damage is depicted in Figure 16.

Analysis of the birdstrike films and the failed transparencies indicated that cracking and subsequent failure paths were initiated at the bolt holes behind the impact point. This was expected, because the bolt holes are sites of stress concentration. The F-111 ADBIRT windshield is especially sensitive to edge attachment failure at the aft arch because of the limited distance between the fasteners and the edge of the

windshield. The edge distance is dictated by the aft arch forward flange geometry and is approximately half an optimal edge distance. One good indication of polycarbonate ductility is the amount of bolt hole deformation behind the impact point. As the transparencies age, bolt hole deformation decreases and the chance of developing cracks at the bolt holes increases. This is an indication of decreased fracture toughness and possible embrittlement. The amount of crack branching into the polycarbonate plies from the edge attachment and the punch-through failures indicate that the polycarbonate properties may be changing throughout the windshield, not just at the edge attachment. Fracture toughness describes a material's ability to resist crack propagation. A decrease in fracture toughness means that the material is more notch sensitive and has less resistance to crack growth. Polycarbonate embrittlement is characterized by a decrease in plastic deformation and ultimate stress.¹⁰ In addition, it is hypothesized that as the polycarbonate becomes degraded, the strain rate sensitivity increases. At low impact velocities, the critical fracture toughness or embrittlement strain and/or strain rate are not exceeded, resulting in normal elastic-plastic behavior; but at high velocities the critical strain and/or strain rate are exceeded, resulting in elastic response followed by brittle failure (unstable crack growth) with little or no plastic deformation evident.

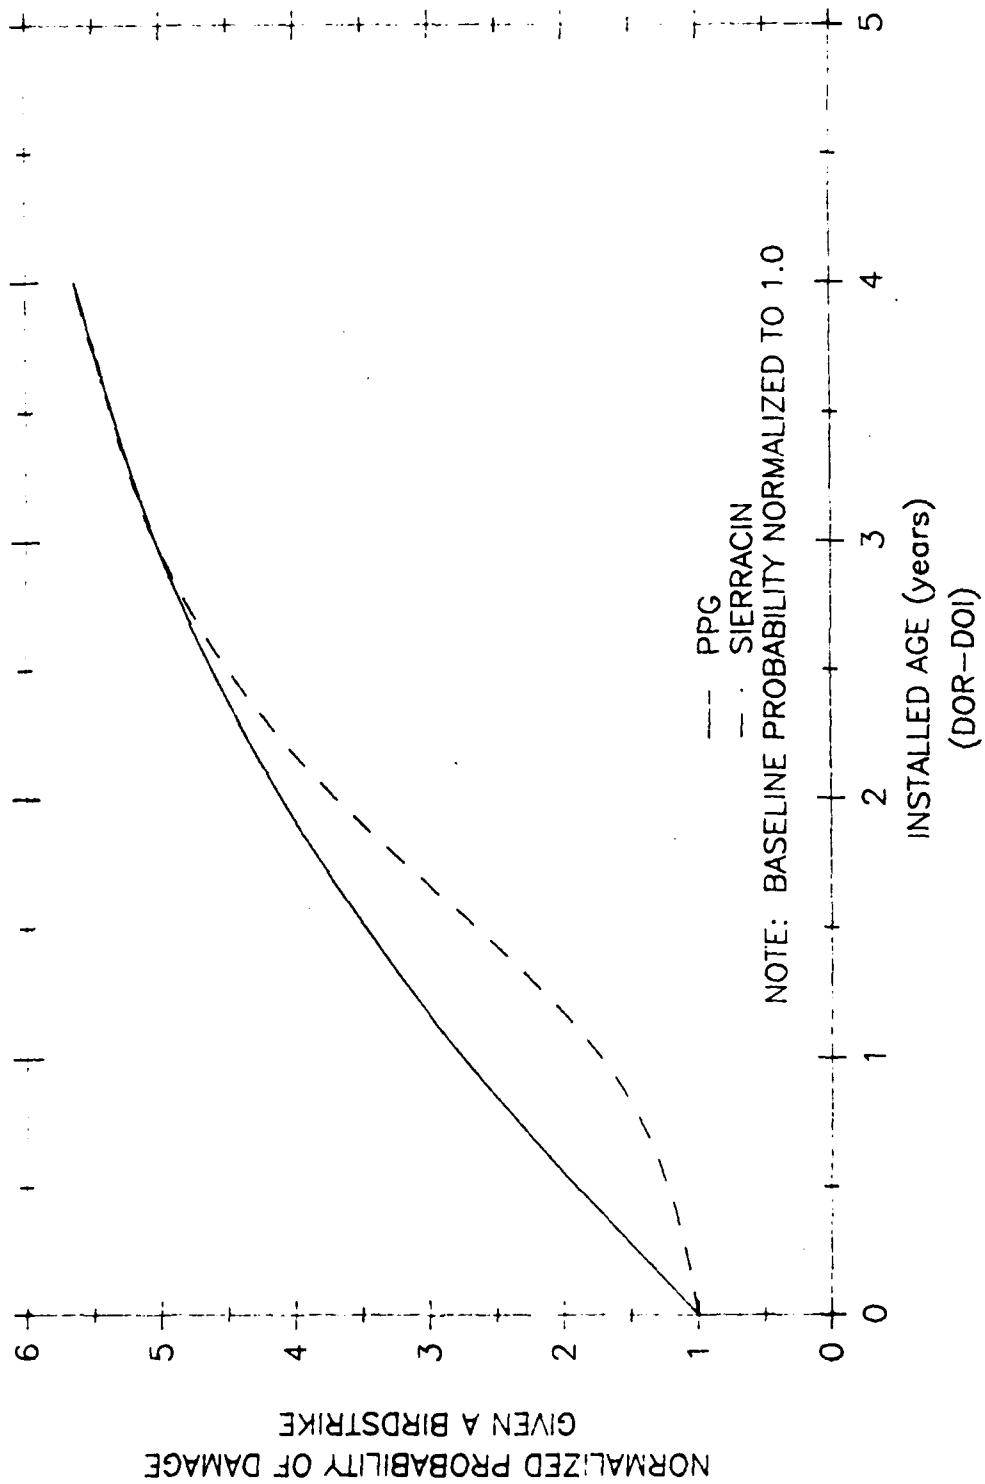
Figure 20. A Comparison of Birdstrike Risk for Sierracin and PPG.

To evaluate the risk of flying the F-111 with degraded windshield panels as compared to new windshield panels, a birdstrike risk assessment analysis was made using a computer program which was developed by UDRI under contract with WPAFB¹¹. This program utilizes a windshield function which is developed from a frontal view of the transparency with predicted bird impact resistance capabilities, see Figure 17; a birdweight probability curve, see Figure 18; and velocity profile data, see Figure 19. The program uses this data to calculate the probability of damage (penetration) given a birdstrike. Table 5 presents probability of damage given a birdstrike for velocity profiles from United Kingdom and western United States bases. The numbers presented give relative comparisons between baseline and aged transparencies; for instance, a four year installed age transparency is approximately 5.5 times more likely to be penetrated by a given birdstrike than the baseline transparency. A plot of normalized probability versus installed age is presented in Figure 20. This plot shows that the PPG windshields are at greater risk, in the first 2.5 years, of being penetrated by a birdstrike than the Sierracin windshields.

Birdstrike risk assessment of the windshields indicates that, given a birdstrike, degradation causes the likelihood of penetration to increase significantly. A two-year installed age F-111 ADBIRT windshield is 3.5-4 times more likely to be penetrated by a given birdstrike than a newly installed windshield. A five year installed age windshield is six times more likely to be penetrated by a given birdstrike than a newly installed windshield.
